# The Locomotive

THE HARTFORD STEAM BOILER  
INSPECTION AND INSURANCE CO.

**VOL. XXXVIII**

HARTFORD, CONN.  
1930-1931

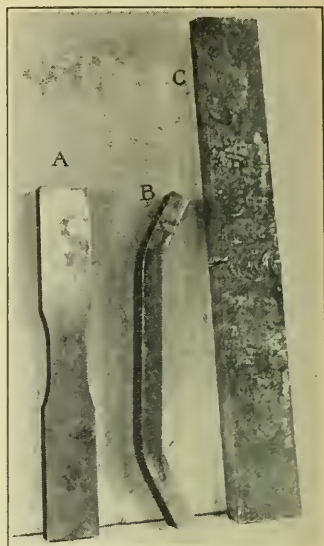
FIGURE 2 — The Company's standard test coupons: (A) Tensile Test; (B) Free Bend Test for Ductility; (C) Nick Break Test for Soundness.

When the Company started its study of welding, the old standard tensile test was practically the only one that was being used to any great extent. That form of tensile test specimen was not considered entirely satisfactory, so the Company set about to develop a form of tensile test specimen which its engineers felt would be more adequate for the purpose. (See Figure 2, A.)

tell anything conclusive about the strength of the welded joint. The Company considered that for such tests its special tensile specimen should be used. (Figure 2, A.) It will be noted that the reinforcement of the weld is removed and the specimen reduced

in width over a length sufficient to take in only the weld and a short section of the plate on either side of the weld. In this way the failure under tensile stress is forced to take place within the weld metal or at its boundaries, thus giving the tensile strength of the joint.

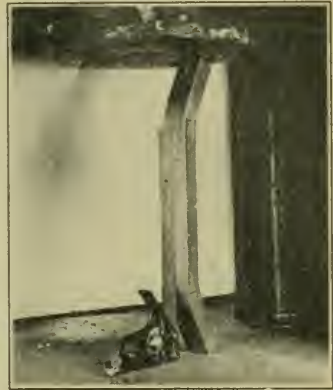
FIGURE 4—Start of the Free Bend Test for Ductility.

joint, and is known as the "free bend test". In Figure 4 is shown a specimen prepared for test. Two center punch marks or scribed lines are made on the surface of the weld slightly inside of the juncture of the weld metal with the base or parent metal. The distance between the two lines is measured and recorded and the specimen is then bent as shown in Figure 5, the maximum bending being forced to take

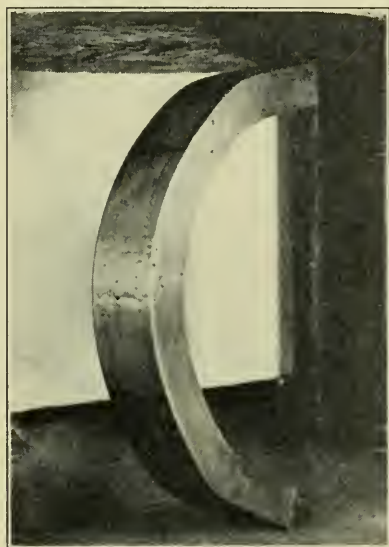
FIGURE 5—End of the Free Bend Test, showing the stretching to which the metal in the weld has been subjected.

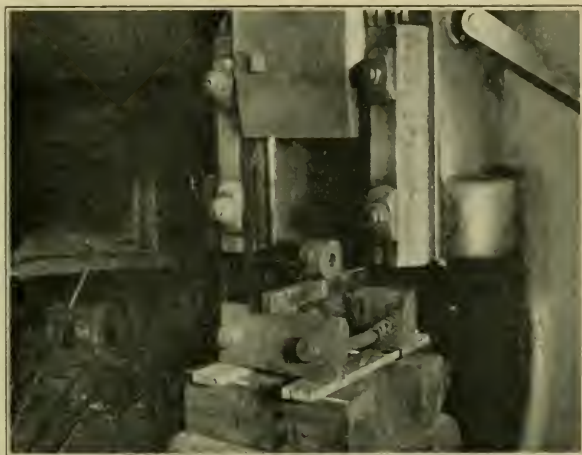
FIGURE 6—*Coupon in place for Nick Break Test.*

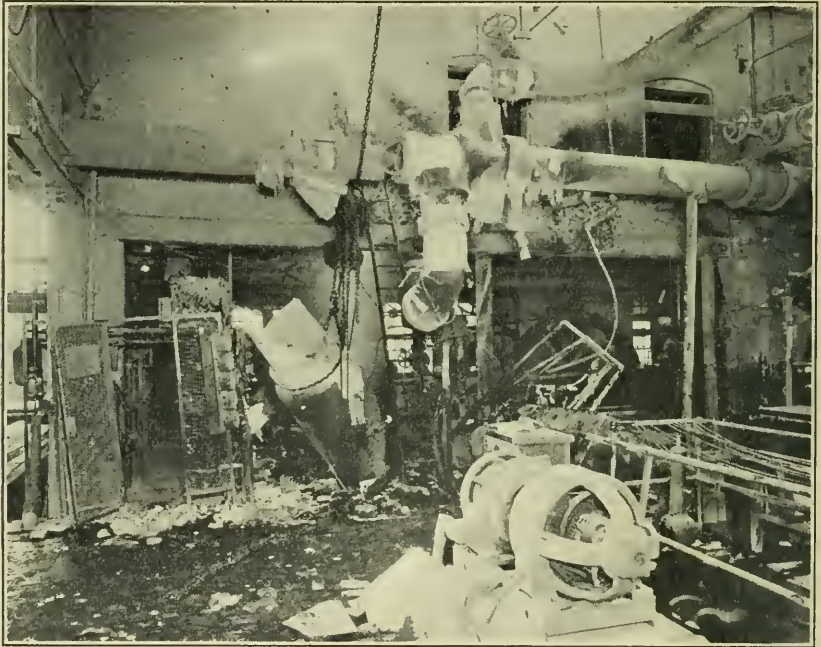
**A**PAPER mill in Michigan was operating at capacity during the early morning hours of February 12 when the main steam header in the engine room exploded with terrific violence, crippled the power supply, and brought plant operations to a complete stop. It is thought that the accident was caused by failure of the cast iron head of a steam separator under the tremendous impact of water carried over from the boilers. Hundreds of feet of piping were broken, bent, and jarred out of line; expensive electrical and measuring apparatus on a nearby switchboard and elsewhere about the room was ruined; holes were blown in the roof and floor; and dirt sprayed thick over walls and machinery.

The destructive effects of the explosion were so far-reaching that production of paper was entirely stopped for one whole day, and approximately sixty-five per cent. prevented for eight days. Fortunately for the plant, it was insured against loss because of stoppage of production as well as against the loss represented by the property directly damaged by the accident. It was paid \$20,502.34, of which \$9,121.17 was for direct property damage and \$11,381.17 for Use and Occupancy.

The real task, however, was to obtain parts and erect quickly a new supply line from the boiler header to the engine room distribution header; to erect a new distribution header with branch lines to the engines; to install a 500-foot rope drive; repair or replace various pieces of electrical equipment; and to check over machinery for possible damage that would prevent its functioning when the plant was again ready to resume operations. It was particularly feared that the turbine bearings had been wiped or scored while the machine coasted to a stop without sufficient pressure on its lubricating oil line, so while the other work was under way this machine was dismantled and inspected.

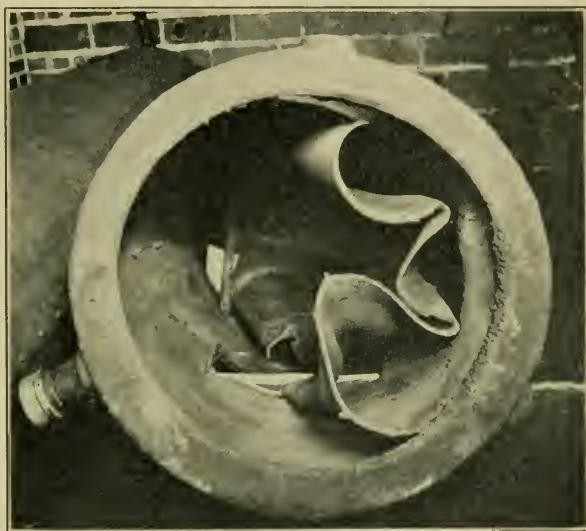
Trouble with the thermostatic regulation of gas-flow in relation to water temperature, and failure of the relief valve to function at a reasonable pressure, probably were responsible for the violent explosion of a steel hot water supply tank in an undertaking establishment. The tank was of the storage type, with an integral heating unit below it. All seams were fusion welded, the longitudinal seam a lap joint, fillet-welded on the outside only. The heads, both of plus design, also were fillet welded.

the flame was unusually high and the water unusually hot. After an unsuccessful attempt to regulate the thermostat, he shut off the burner and called the local gas company. Adjustments were made, but the trouble must have persisted, for two days later the tank exploded. Although every seam was torn apart, it is thought that overpressure, resulting from the non-functioning of safety devices, was to blame, rather than possible weakness of the welds, which seemed to be of good quality.

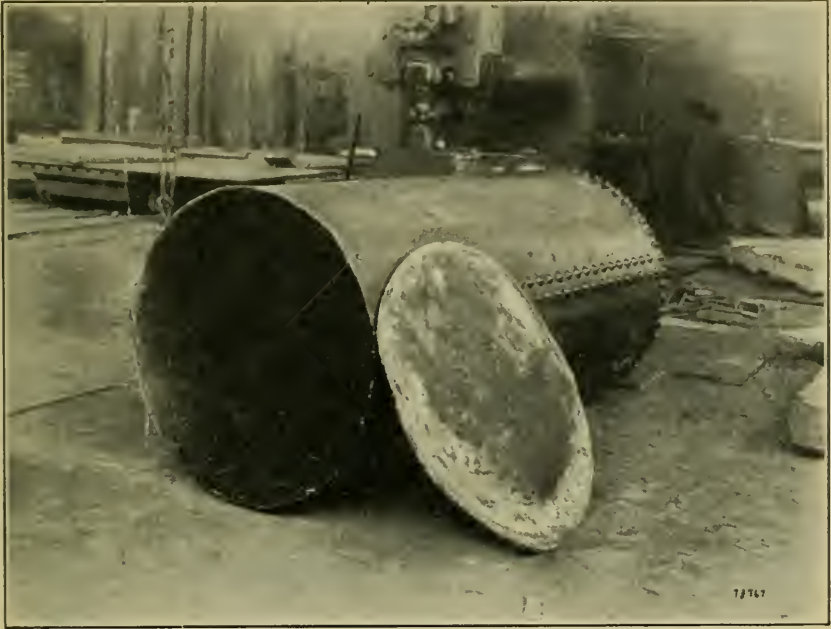
*Figure 1*

The tank was 36" in diameter, 6 ft. long, and was made of  $\frac{1}{4}$ " plate with double riveted lap joints. Its lower head, however, had at some time been replaced with a shallow, skirtless head fastened in place by welding. The explosion occurred when the weld material sheared and permitted the saucer-like disc to tear loose around its entire circumference. Figure 1 shows the flatness of the head and the manner in which failure took place.

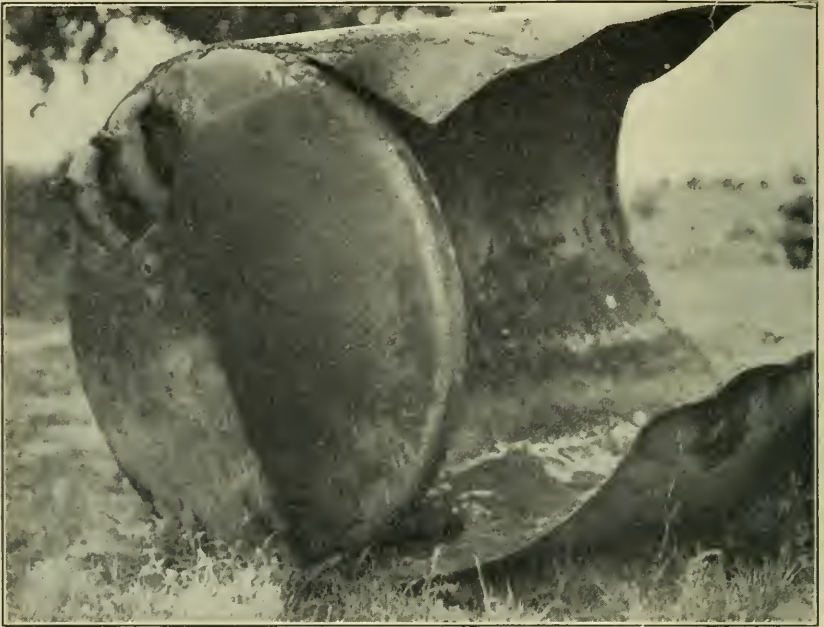
*Figure 2*

in the hydro-pneumatic system of water supply. They overlook the fact that, although the tank is partly filled with cold water, the compressed air in the remaining space renders the container as dangerous as any air receiver.

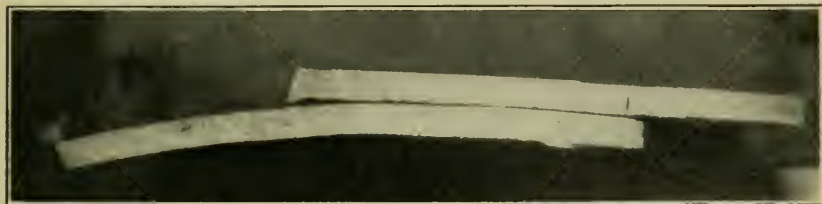
*Figure 3*

to justify further investigation. The one-half inch diameter hole, visible below the marker pasted on the plate, was drilled into the outer surface of the plate opposite the location where it was thought a crack was developing. The drill did not reach a depth equal to one-quarter the thickness of the plate before the crack was visible across the bottom of the drill hole, as may be judged from the depth of the crack as shown by Figure 3. Owing to the limited range of the telltale holes the exploration slot is preferred and has been used to great advantage since full detail of the method was published in *THE LOCOMOTIVE* of October 1914.

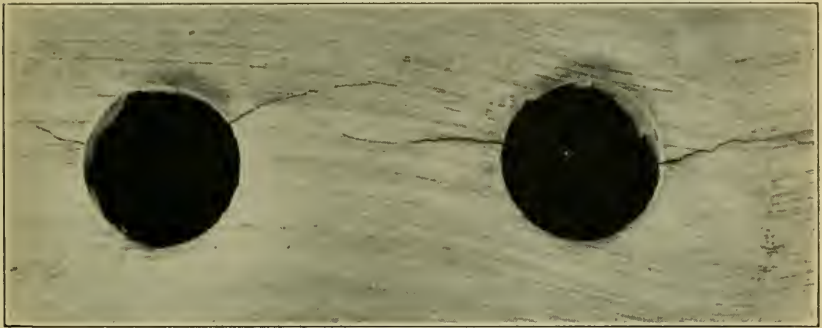
*Figure 6*

A comparison of the details of Figure 4 with those of Figure 6

tlement defects, whether found in the lap seam or butt strap seam of a steam boiler, reach out in several directions from each of several rivet holes. As in the case of the lap seam crack, there is no serious weakening of the vessel at the start, but the long-continued and progressive deterioration of the cement binding together the microscopic steel crystals may, over a period of time, extend the weakened condition so far into the plate that steam pressure can then cause a sudden and violent explosion.

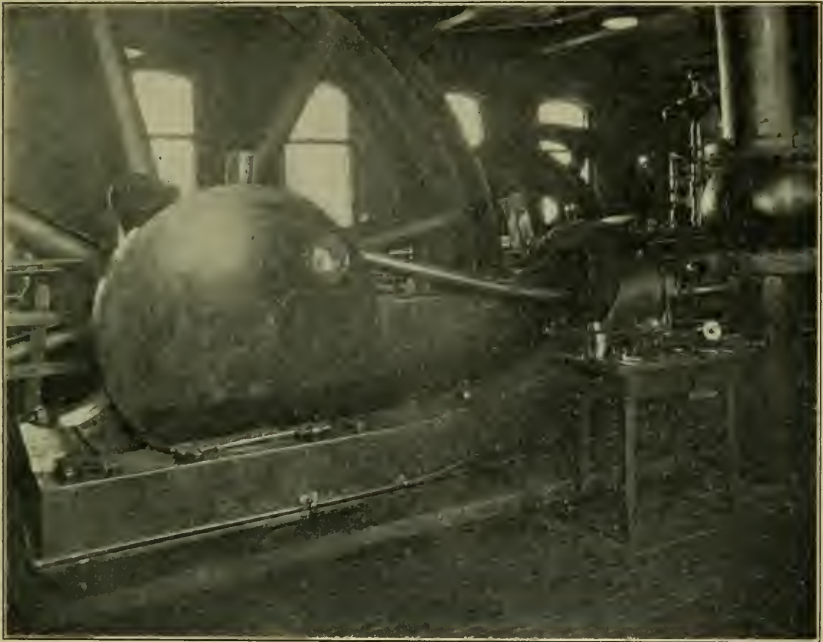
*Figure 1*

**P**ROGRESSIVE cracking of the crank pin at a point inside the disc recently caused an expensive accident to a tandem-compound Corliss engine in a Mississippi cotton mill. The break permitted the reciprocating parts to strike and drive out the rear heads of both low and high pressure cylinders, as well as to break crosshead slippers and

accident occurred. As is apparent in Figure 1, the pin broke off below the surface of the disc where the crack could not have been seen even with the crank removed. The darker part of the fracture shows the extent to which the crack had gradually worked into the pin. The bright part is the area of sound metal that failed at the time of the accident.

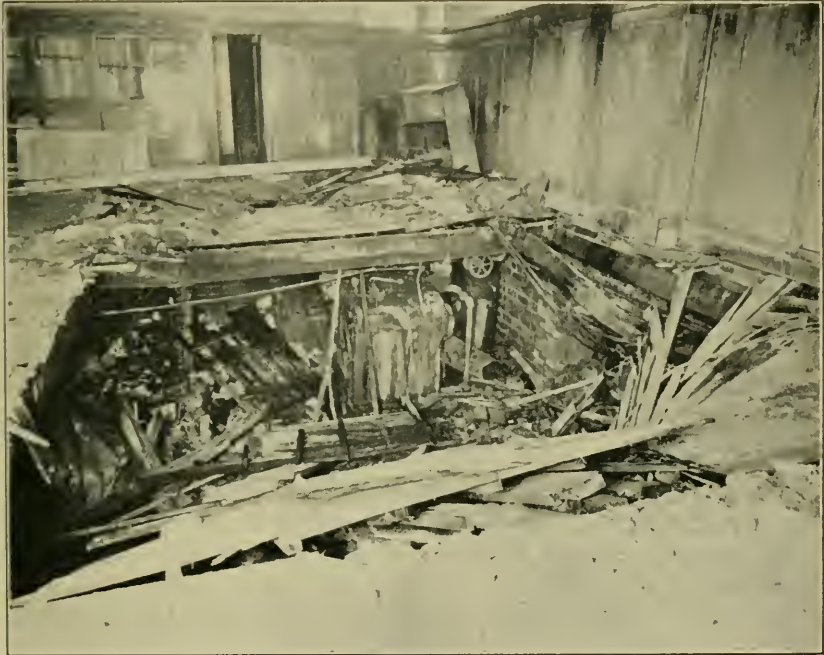
THE account we have received of the heating boiler explosion pictured below, indicates that the safety valve was either inoperative or else it was not large enough to relieve pressure that increased rapidly when an attendant closed the stop valves in both the steam and return lines. This accident occurred on December 2 at the

showroom of a large automobile agency, and although several automobiles on the showroom floor were badly damaged—two of them falling into the hole shown in the picture—only one person was injured. That happened to be a passerby who stopped to look at the display of cars and was cut by pieces blown from the plate glass window.

Two coal fired cast iron sectional boilers comprise the battery used for heating the showroom. During extremely cold weather both boilers are used at a pressure of from five to ten pounds, but at the time of the accident the weather was unusually mild and only one boiler was in use.

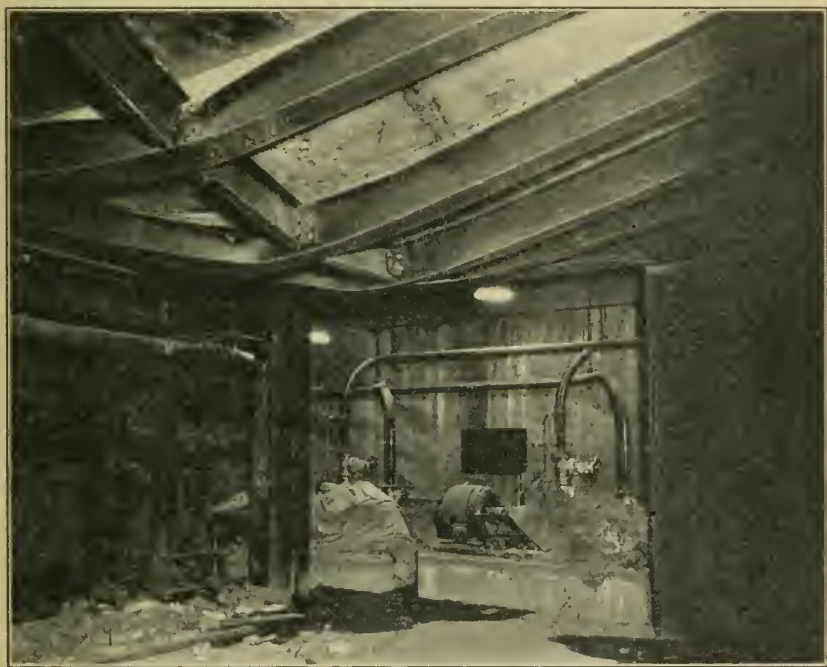
## Natural Gas Furnace Explosion at Colorado Springs

ONE man was killed and three others were injured by a terrific explosion of natural gas in the furnace of a boiler at the municipal plant of Colorado Springs on the morning of January 31. Occurring with such force as to destroy the brickwork of the boiler setting and bend the heavy 12-inch I-beam supports as though

they were putty, the blast endangered the lives of between 20 and 25 workmen engaged in putting the finishing touches on the new plant.

The boiler, a large one of the cross-drum, straight-tube type, had been put in place, and men were about to boil it out to prepare it for an acceptance test when a torch thrust into the combustion chamber ignited a charge of gas that had accumulated there. The resultant explosion not only rocked the boiler almost loose from its support but burst out the metal framework of windows in the building and did considerable damage to the brick walls of the setting and the power house.

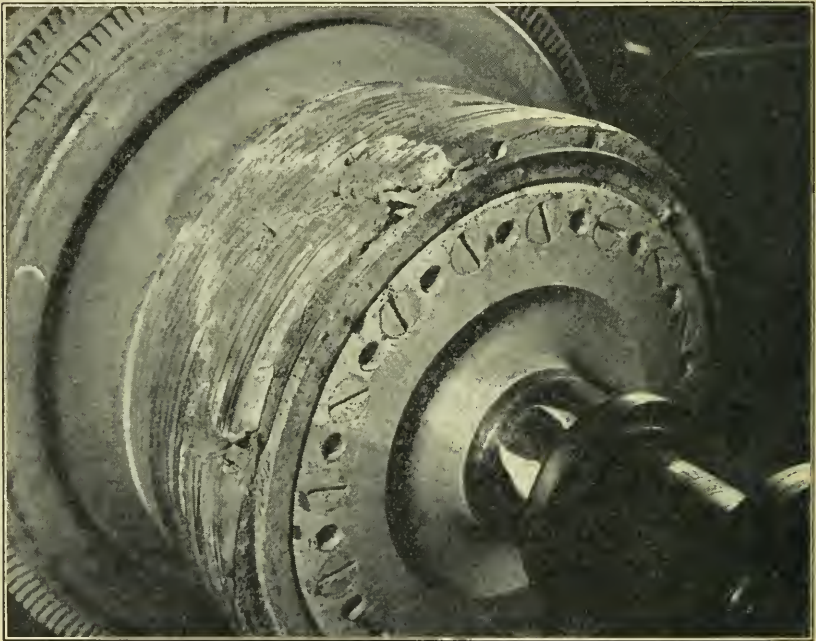
An accident to a 3750 kva turbine at Charleston, West Virginia, the basic cause of which was undetermined, manifested itself in a breaking of the rotating dummy ring (see illustration), rubbing of

and injury to blades, and a distortion of the spindle. Because of reports of smoke between the oil tank and the turbine casing, prior to the failure, and indications at several places of excessive heat, the theory was advanced that the burning of confined oil in the asbestos lagging caused sufficient heat to warp the casing, thus causing the stationary and the movable dummy ring to rub, leading to a chain of events which brought about serious damage. Repair costs in connection with this accident exceeded \$15,000. Restoration of the turbine's usefulness involved repairs to the spindle, replacement of blading, and replacement of the spindle and cylinder dummy rings, gland runners, gland cases, primary nozzle block, governor stand and some other parts.

Repairs to the bearing bracket were required, with a general inspection and repair of the entire mechanism.

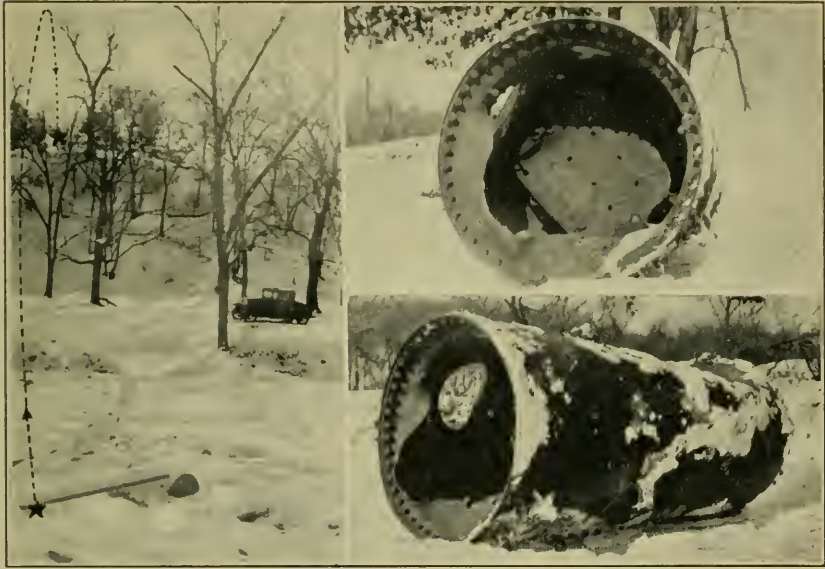
*After the explosion—the boiler and where it went. The view at the left will give a good idea of the path of the Marseilles, Illinois, mine boiler. It followed approximately the path indicated by the broken line, passing upward over the trees and hill to a resting place 700 feet distant. The pictures at the right show end and side views of the boiler, the former revealing how the firebox was forced up against the tubes, and the latter showing the firebox opening and the dent caused when the boiler landed.*

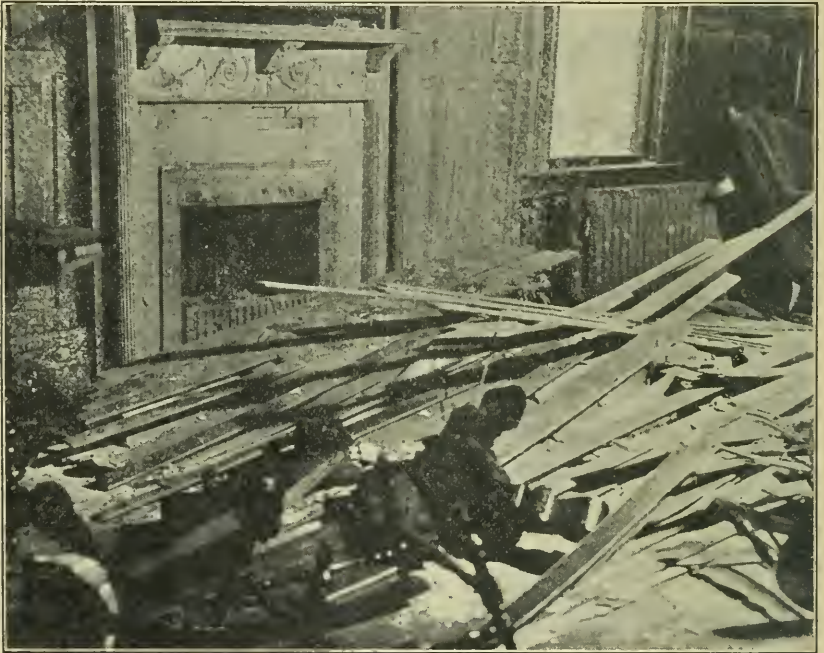
A furnace gas explosion in the basement of Governor William G. Conley's executive mansion at Charleston, West Virginia, nearly resulted in the death of West Virginia's first citizen. Becoming chilly on a Sunday night and knowing that servants were away he went personally to the basement to determine why the gas burner in the furnace was not functioning. Cautiously he opened the furnace door with a stick and an

explosion of terrific violence occurred almost immediately. Governor Conley was burned about the face, but he was able to shut off the gas and avert further trouble. The cause of the accident was attributed to ignition of the gas and air in the furnace by a pilot of a nearby hot water heater. Damage to the mansion was estimated at \$1,000.

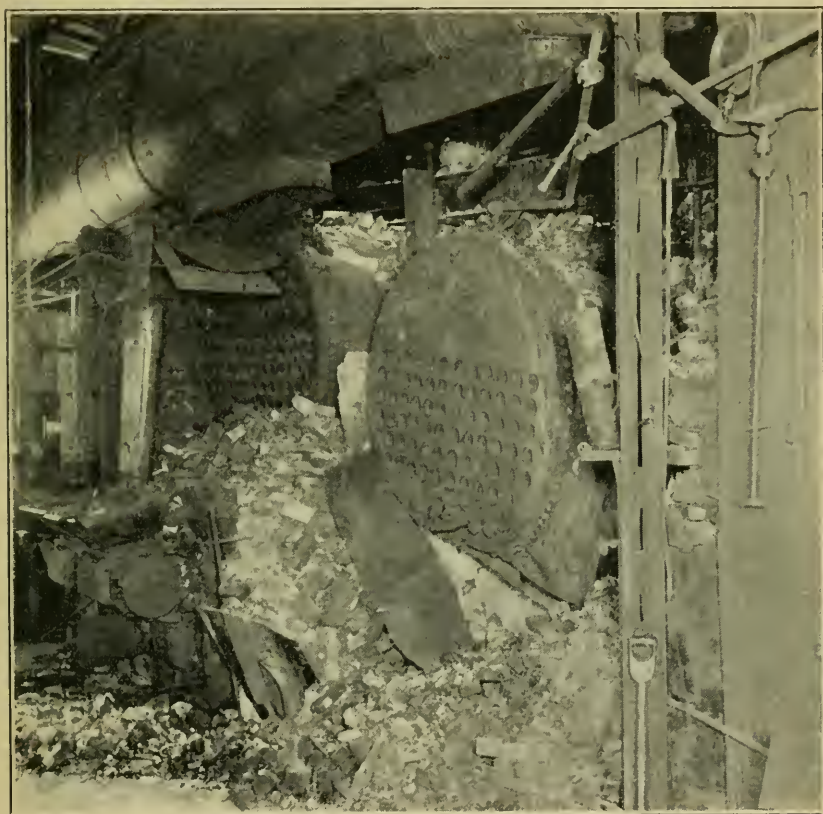
*After dairy boiler bulged and ruptured*

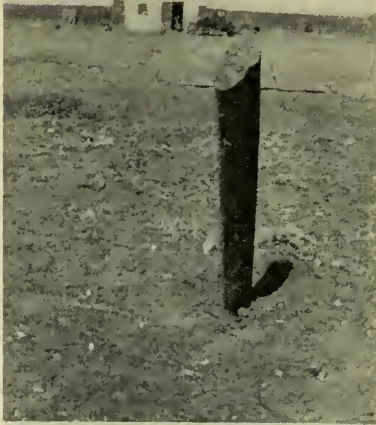
*Above—An arm of the wheel "javelin-minded".*

*Below—Piece of rim 200 yds. from the engine.*

One theory was that the water leaking from the blow-off valve filled the wheel pit to such a level that the main driving belt lost its traction, and that this resulted in an alternate slipping and grabbing of sufficient severity to break the belt. There was some evidence to support the belief also that while this was occurring the governor belt slipped off either from the erratic behavior of the engine or because of becoming wet by water splashed up from the belt wheel. This governor belt had slipped off on previous occasions, attendants said, but this time the safety cams on the engine valve gear were not in proper position. The result was that the stopping of the governor failed to cut off steam from the engine, as it should have done. As the engine had been relieved of its load by the breaking of the main belt, overspeed developed quickly.

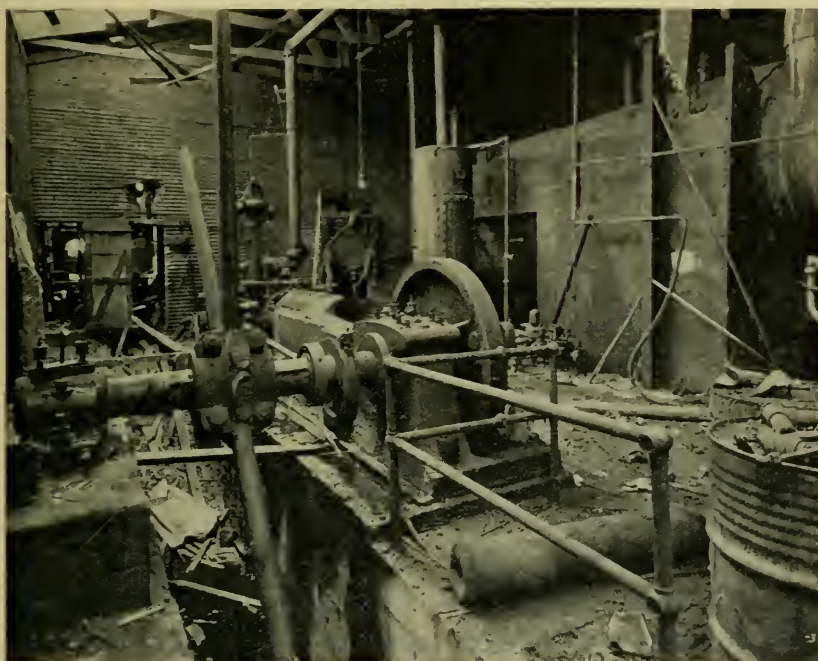
*Engine room after the shattering of the flywheel. All that remains of the wheel is the hub and three spokes.*

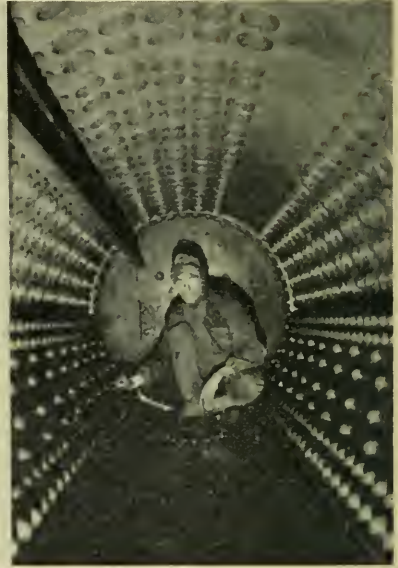
*Exterior and interior views of boiler drum repaired with extra-wide straps to overcome weakness caused by caustic embrittlement.*

THE expedient of applying wider butt straps as a repair of a seam that had been weakened by caustic embrittlement, was made use of recently on batteries of water tube boilers at two different locations in southern states. This form of repair is limited, of course, to cases where the embrittlement is in an early stage, and where the design of the boiler does not prevent the use of wider straps; but in the cases about to be described it was successfully used in adding

several years of life to boilers that otherwise seemed destined for a quick retirement. All the boilers were of the bent tube type, and embrittlement had affected only the longitudinal seams in their lower drums.
